# National Transportation Safety Board

## P-51D The Galloping Ghost

September 16, 2011

Reno, NV

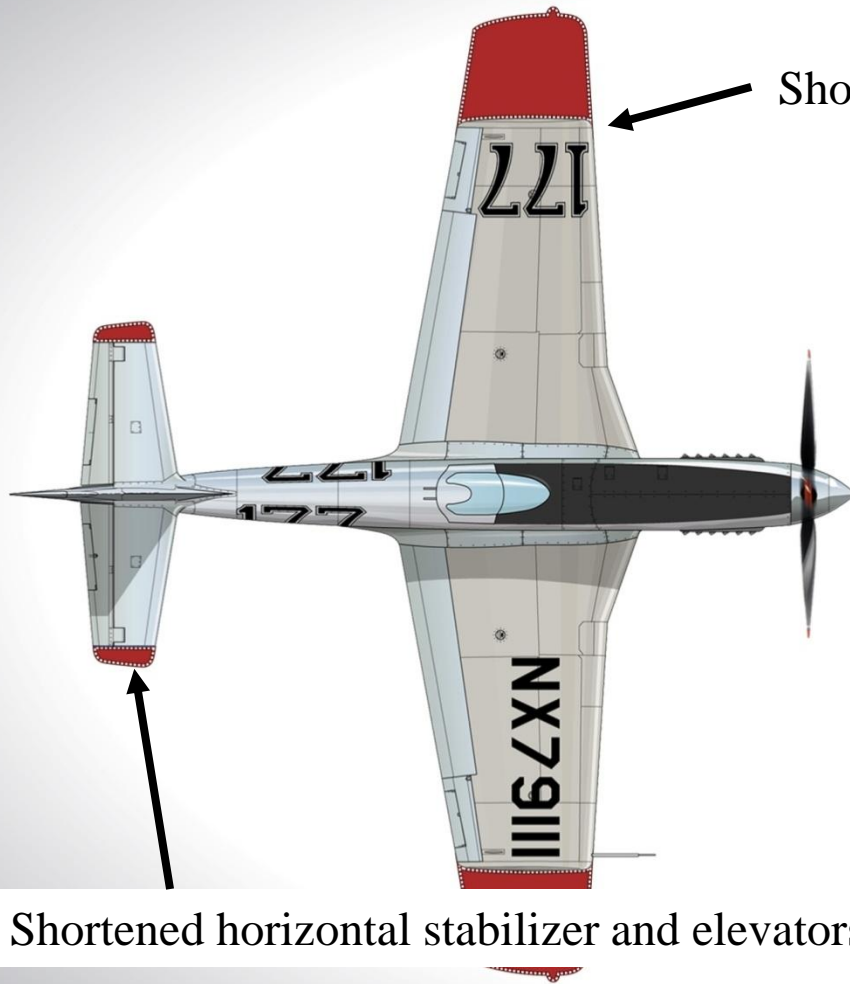
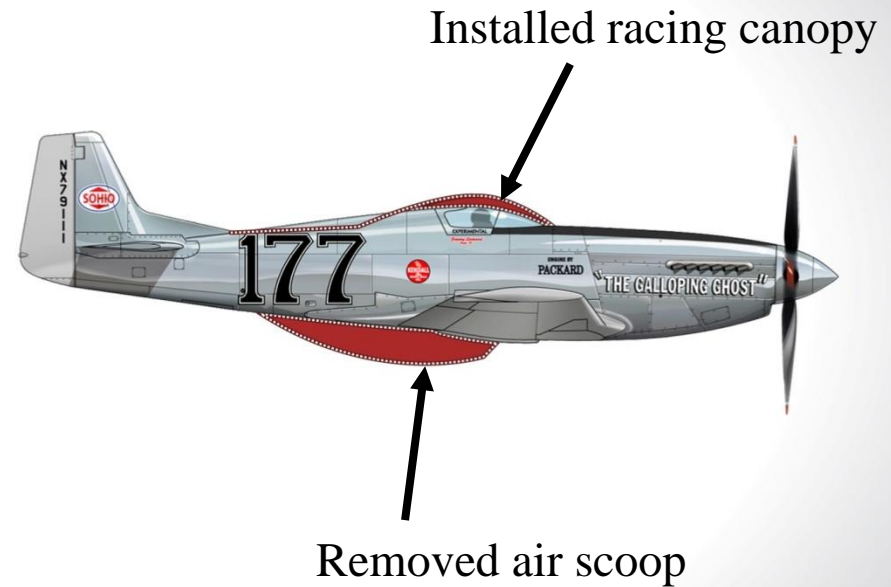
# Structural Modifications

Shortened horizontal stabilizer and elevators

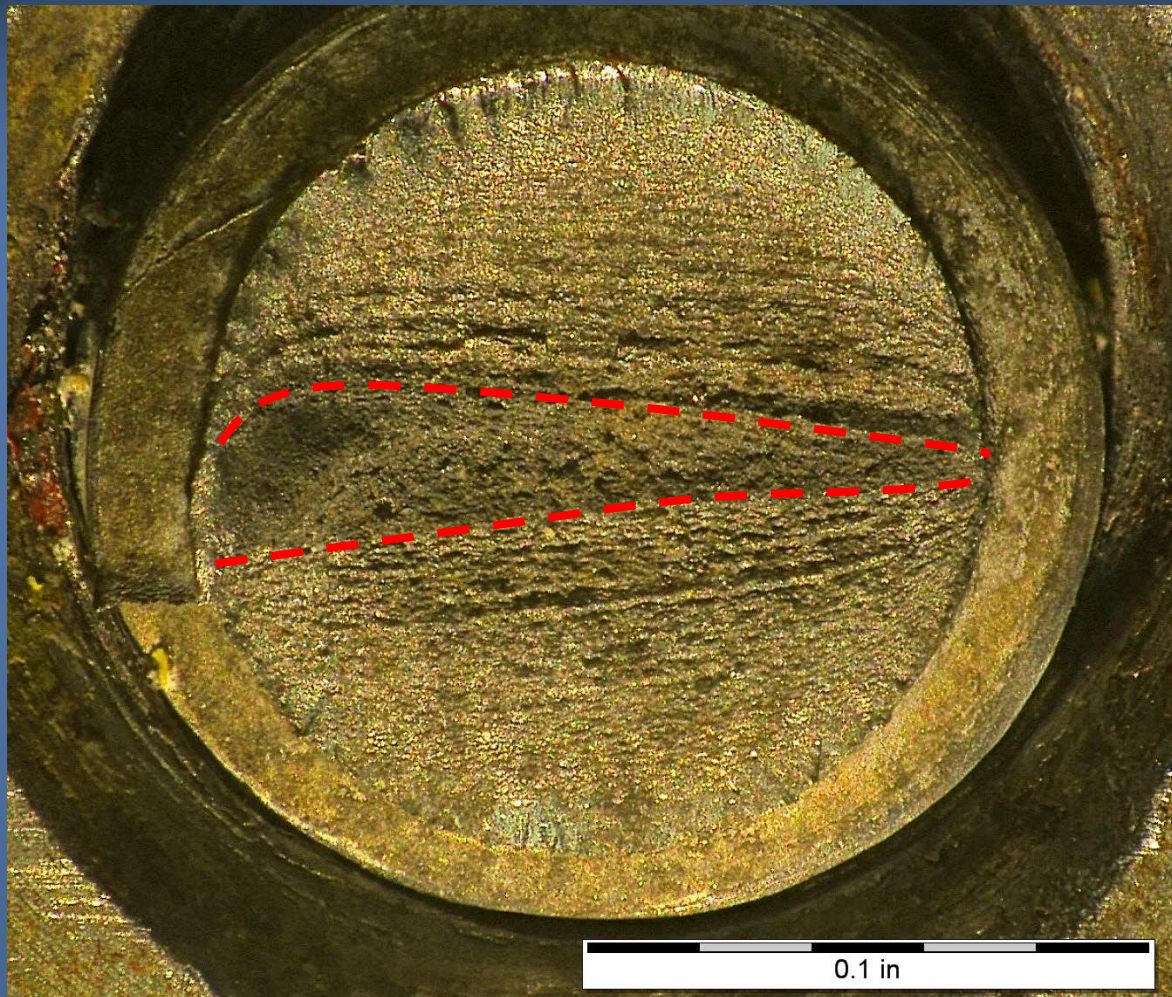
# Left Inboard Attachment Screw

- Link assemblies
  - Overload failure in bending
  - Compressive buckling deformation
  - Internal elevator damage
- Screw
  - Fatigue fracture 80%
  - Overload fracture 20%
  - Corrosion on fracture

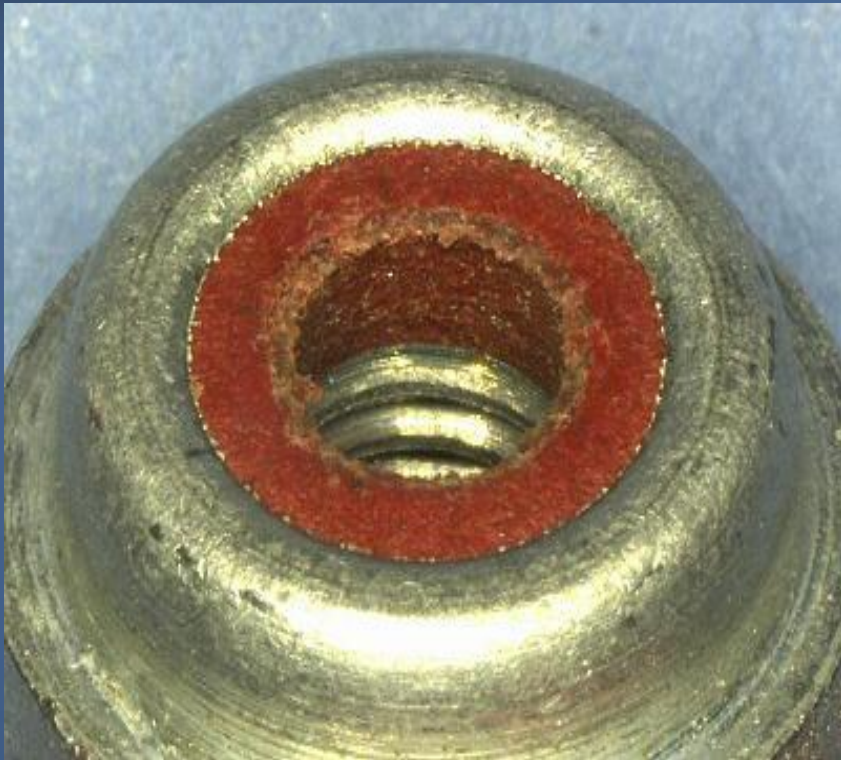
New locknut

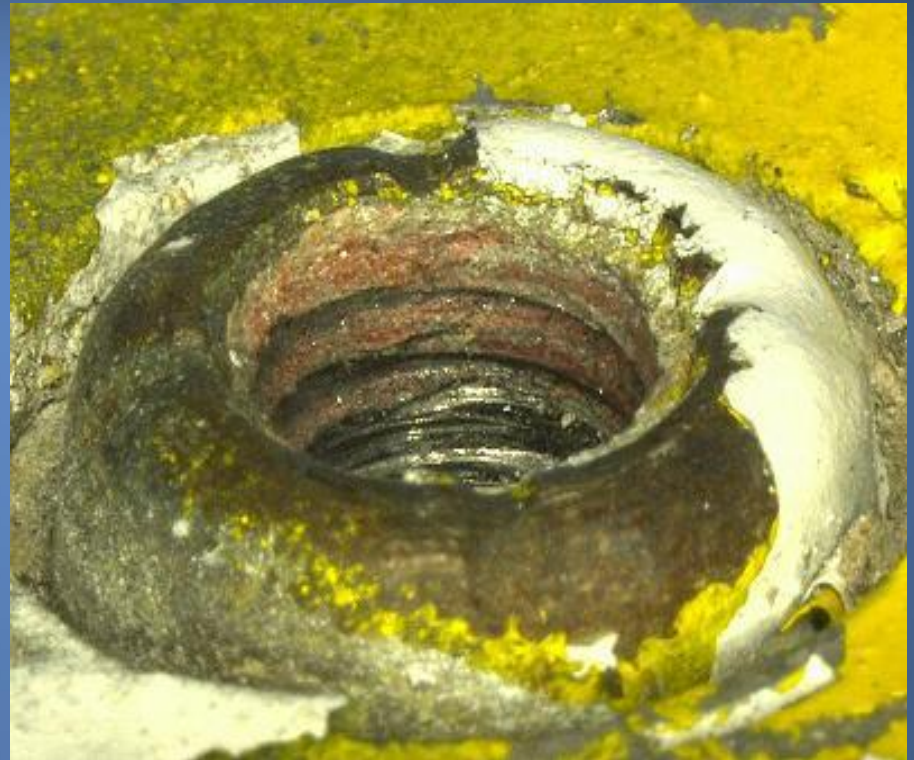
Ghost locknut
